# OCEANSIDE UNIFIED SCHOOL DISTRICT DISTRICT SERVICES OFFICE

50% Construction Documents (issued on April 18, 2023)

Review Report –Rev 00 – June 19, 2023

(Documents analysis, coordination, integration and constructability)

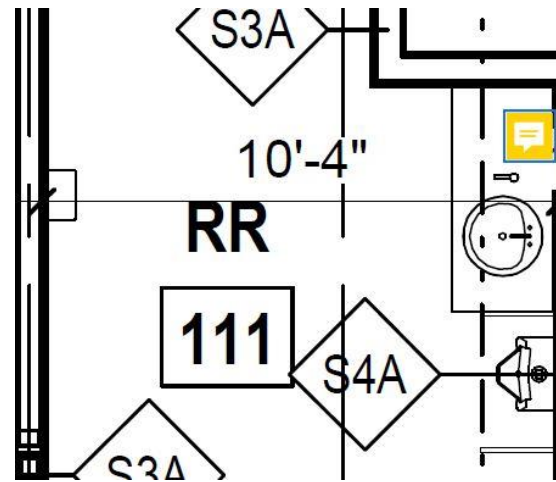
First floor – RN (111, 143)

02-In public bathrooms "RR" please clarify if the number of sinks in enough for the floor occupancy

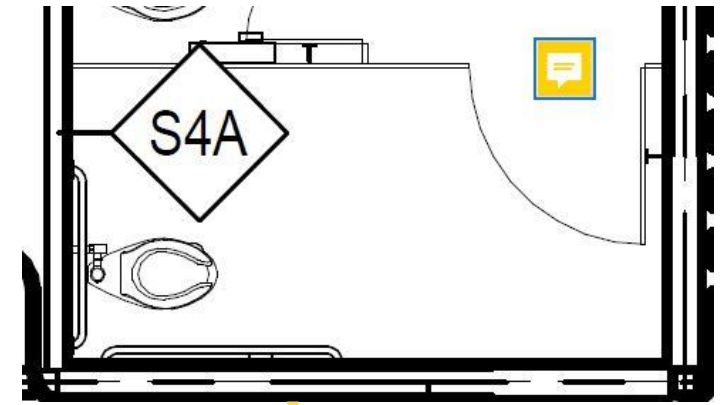
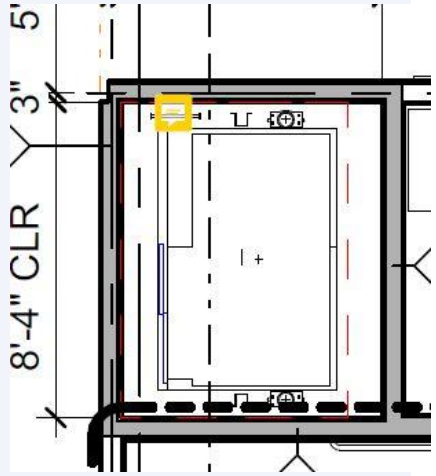
First floor – RN (111, 143)  
 Second floor – RN (213, 214)

03-In the public bathrooms "RR" handicapped toilet door direction open is inside "check and revise the direction "

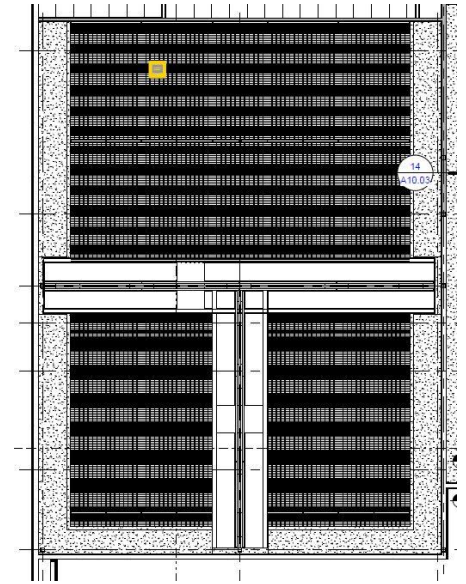
Ceiling plan

05-Revise and checking for all Returning HVAC systems in ceiling plans

06-Re-check and co-ordinate the maintenance access panels in ceiling plans

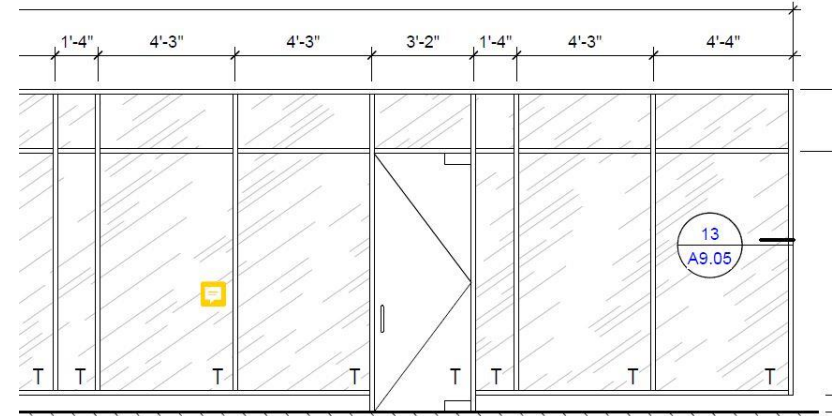
08-There is no description and details for the sliding doors

09-There is no description and details for the "FG" door type

10-In storefront glass there is some of the glasses in Timbered and some else in not Timbered please check

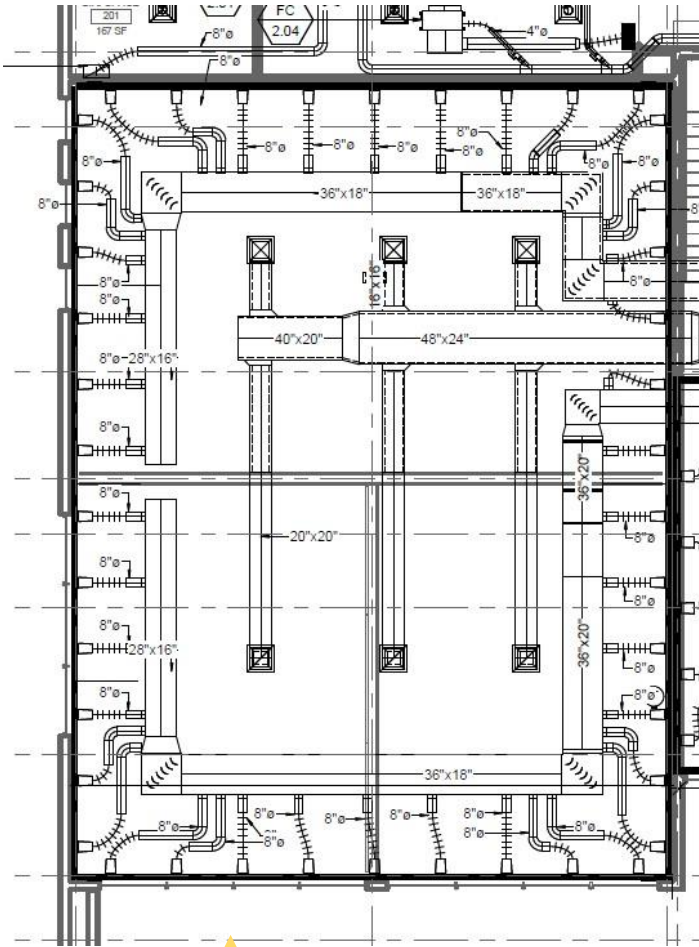
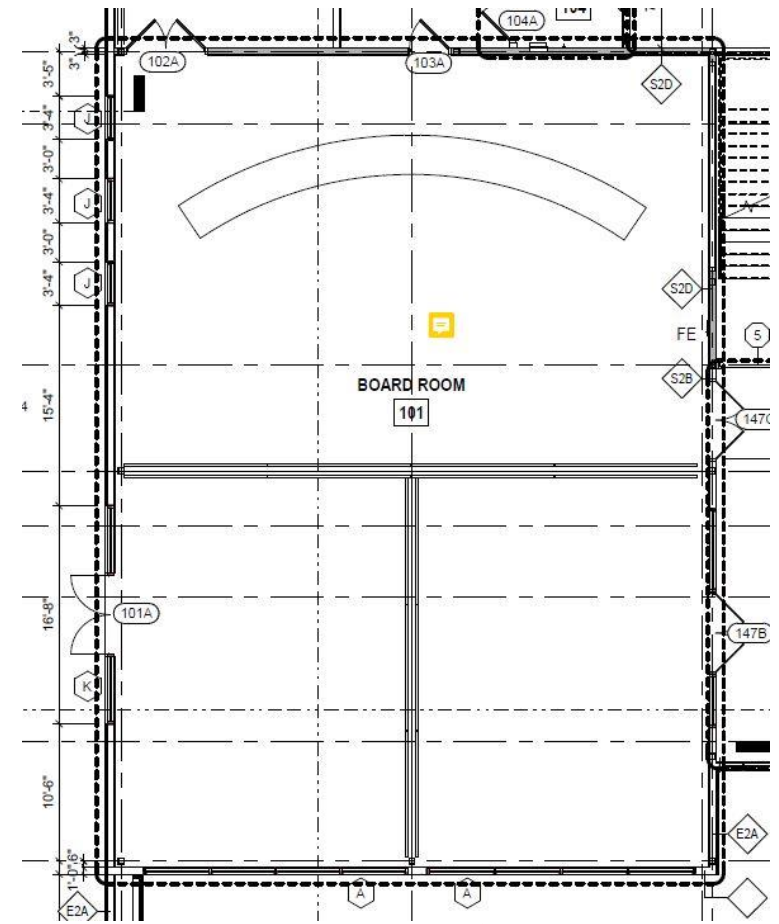
11-The Section Showing the height of the splitter portion

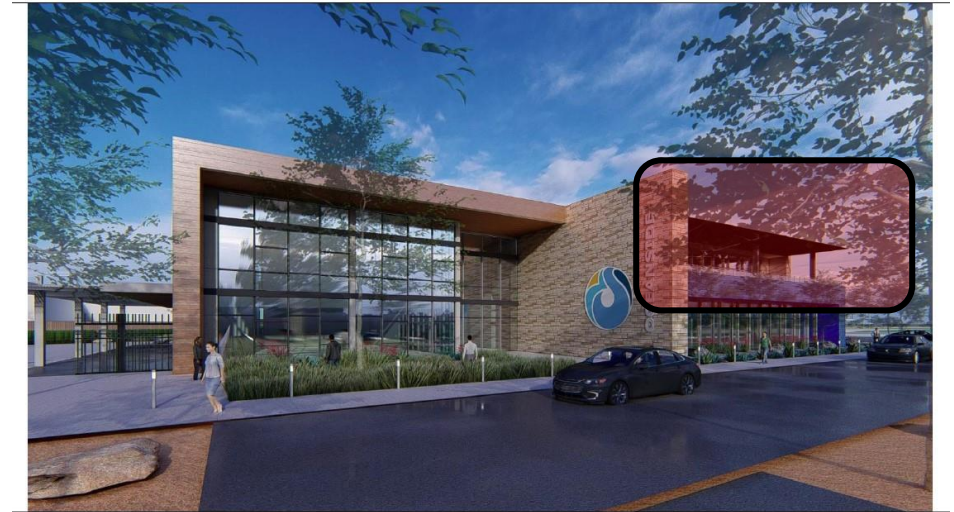
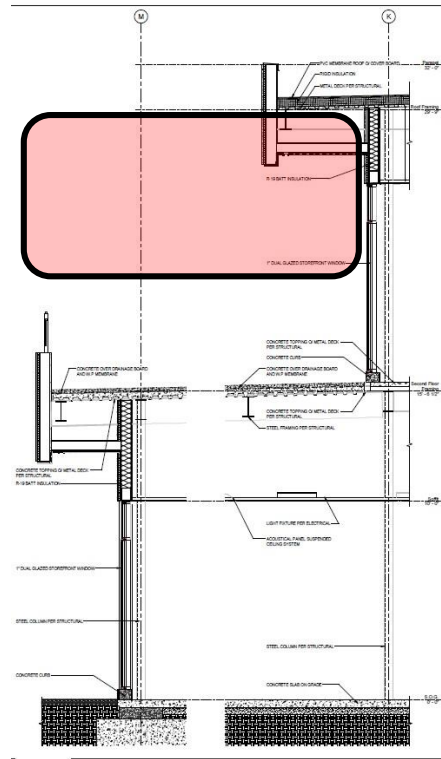
14-The 3D shot showing there is a sunshade above the outdoor terrace in second floor but no details provided or mentioned in architecture drawings

The Section Not showing the tent

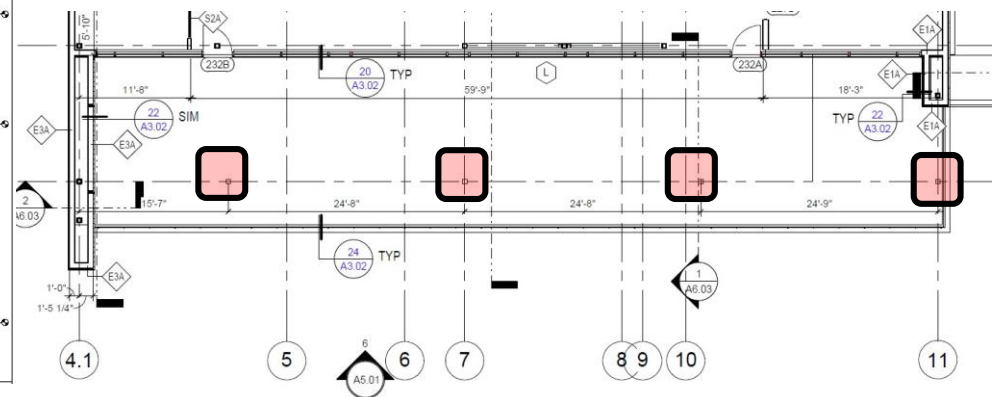
In Terrace showing the columns but no shell

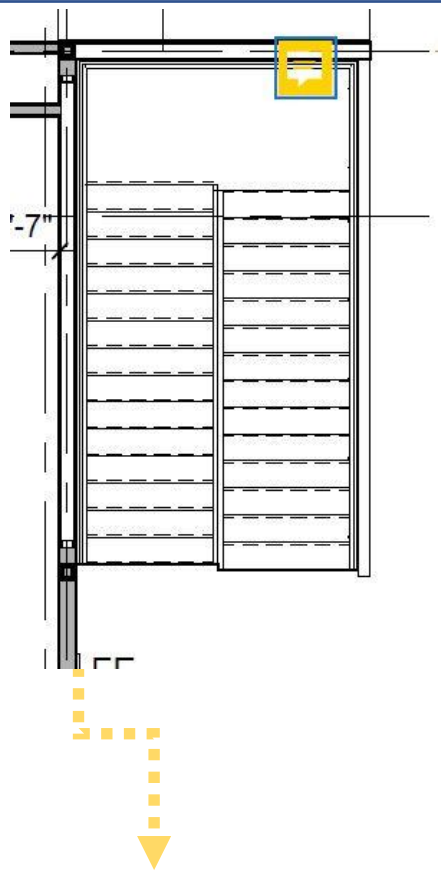
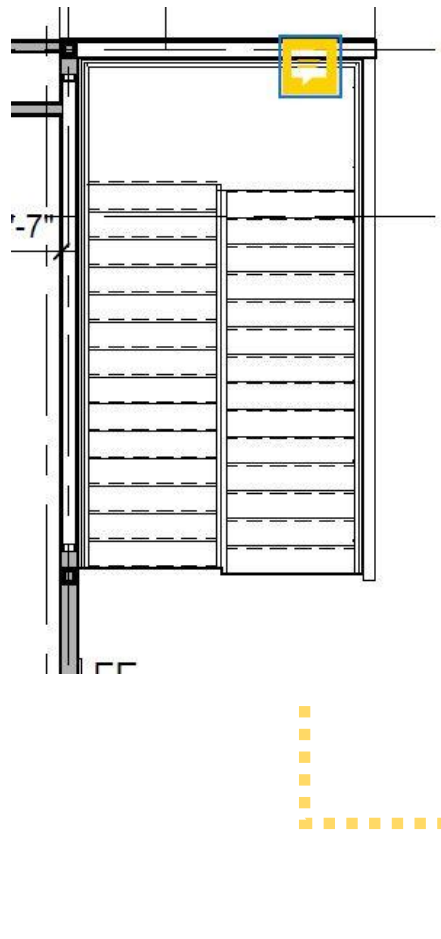
15-There is no details or enlarged plan and sections for the staircase ; showing any details for finish's and levels .

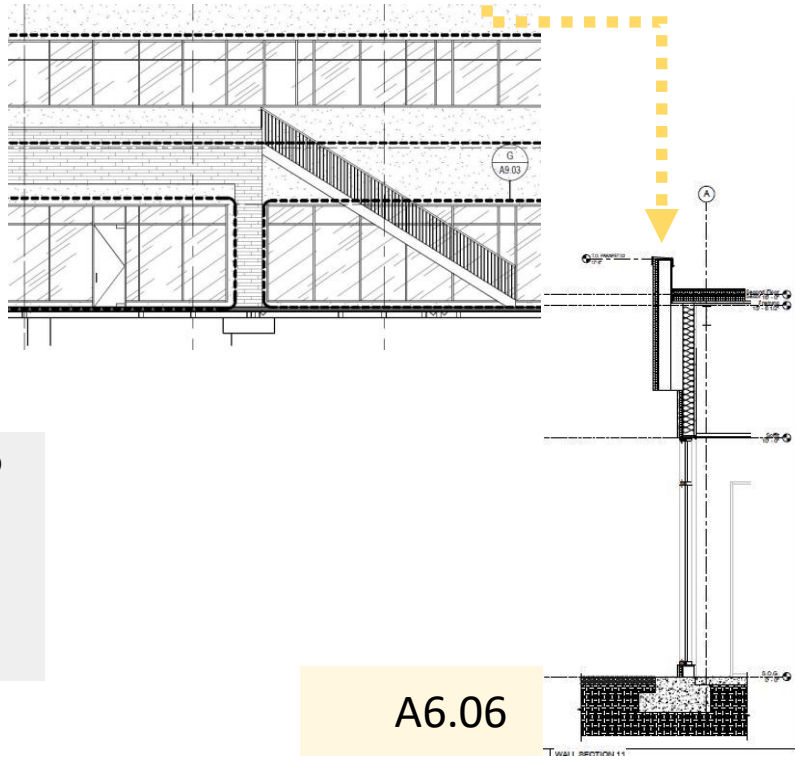
A5.01

17-at the first floor exterior deck along Axe "A" from Axe 6 to 12 Please consider the parapet height while using this external deck as an emergency evacuation plan

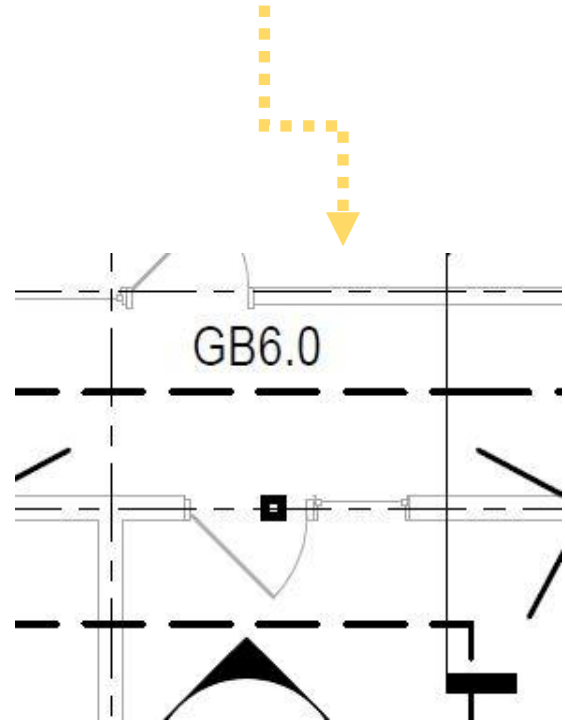
S - 101

18-Check and relocate column "c1" between axe " D & E " on axe " 12 " if relocate is better for the window.

19-Check the door location and co-ordinate it with the steel bracing along axe "D"

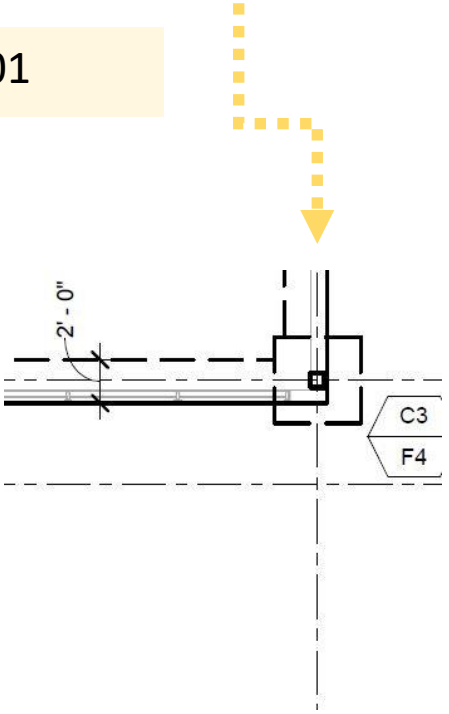
S - 101

20-For example the structural column along axe " 3.1 " referenced to column schedules the width of columns for "c3" is 8\*8\*0.5 and in Architecture drawing Shows that column is embedded in partition type . " E2A" , that's width in 6" please check the thickness of columns that can't applied inside the wall.

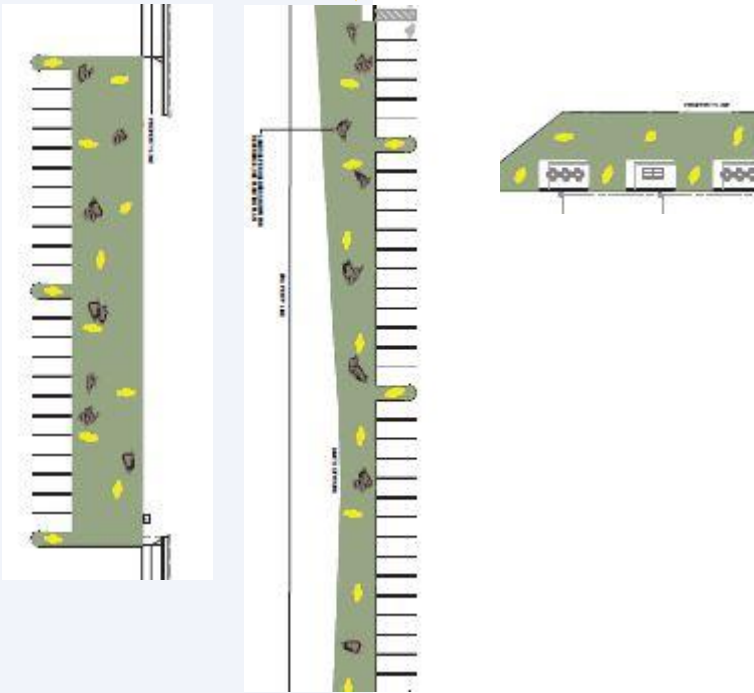
L2.01

01-There is no piping network for irrigation except at property line

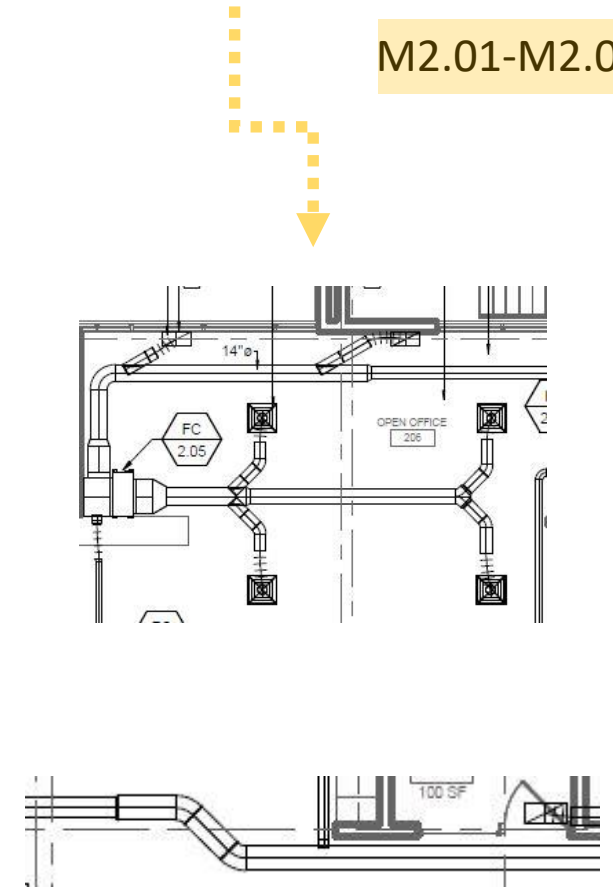
M2.01-M2.02

02-Missing Valves box locations & rain sensor shut off devices

03-All air outlets sizes and cfm capacities need to be clarified

04-missing info for ducts (dimension & air volume)

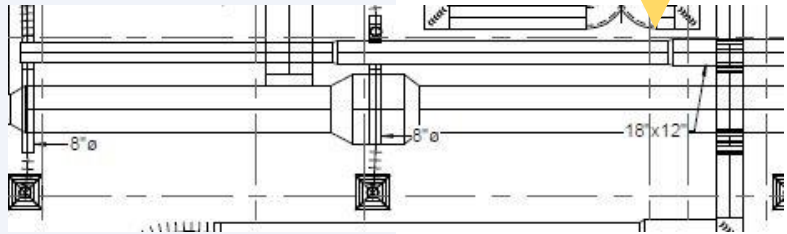
M2.01-M2.02

06-Check fire damper used for fresh air ducts in case of fire scenario

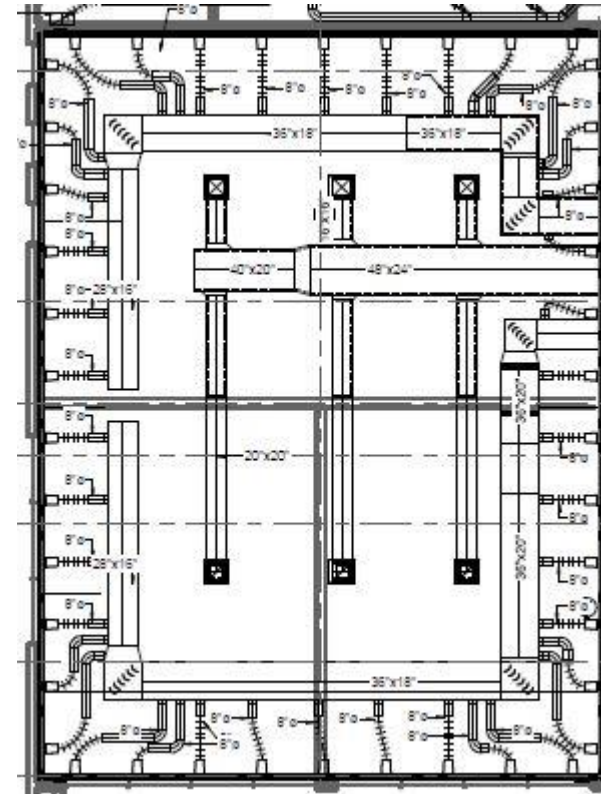
M2.01-M2.02

07-Duct work and flexible routing at board room need to be checked and coordinated with architecture

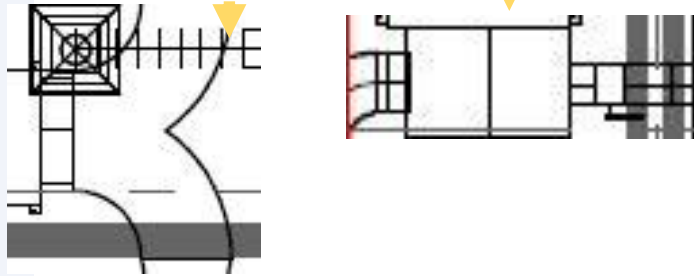
M2.01-M2.02

08-Return air plenum box details needed

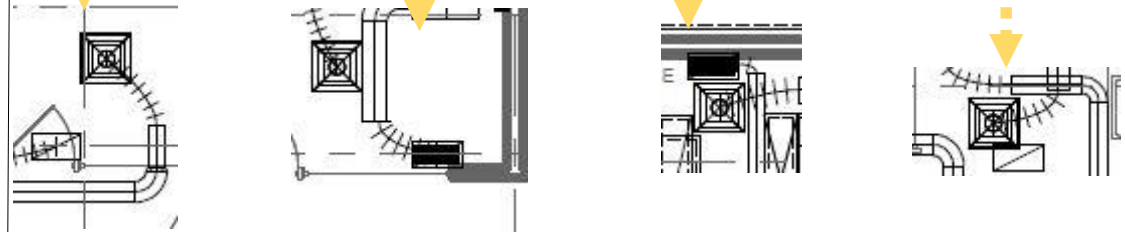
11-Spacing between supply and return grills in some spaces need to be checked to avoid air shortcuts, if any

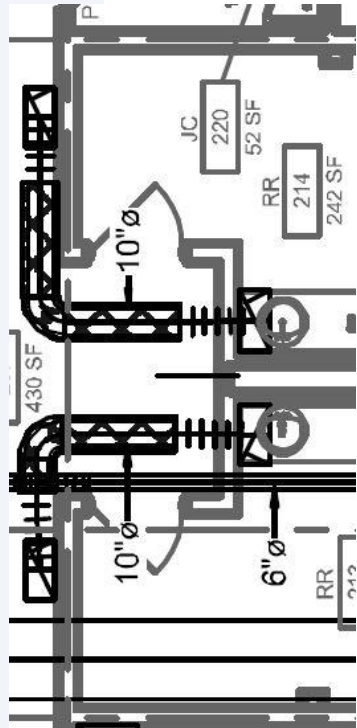
P2.01

13-Clarify the function of the duct serves restrooms (111,112,113,114, .....etc) as per attached sketch.

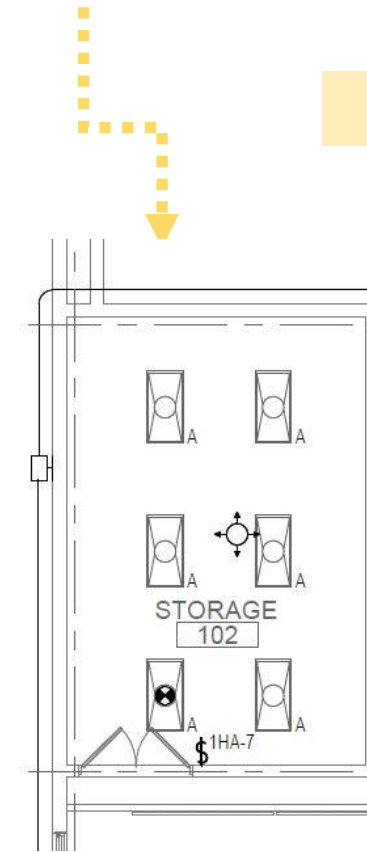
E3.01

20- Check wiring of lighting fixture for room (102,106,107,108,109,116,111,146)

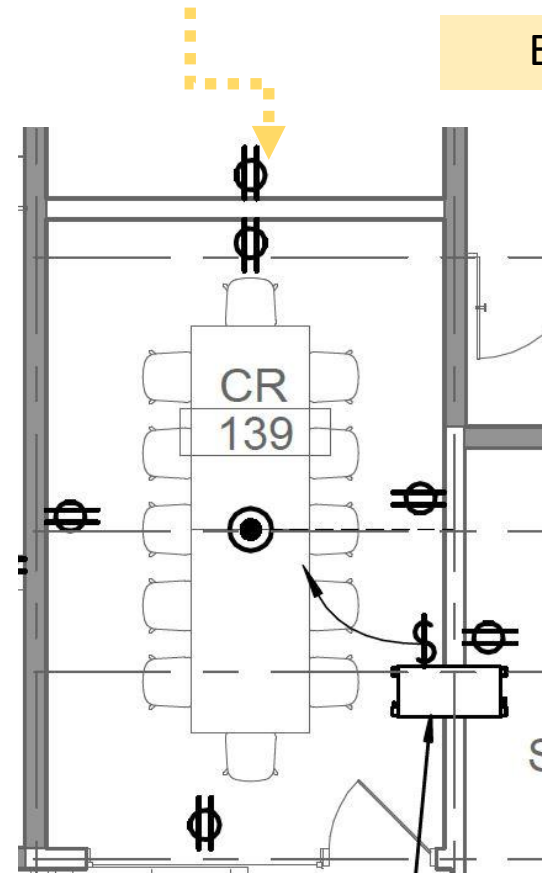
E2.01

26-check for the number of circuits related to the number of power service (E2.01)

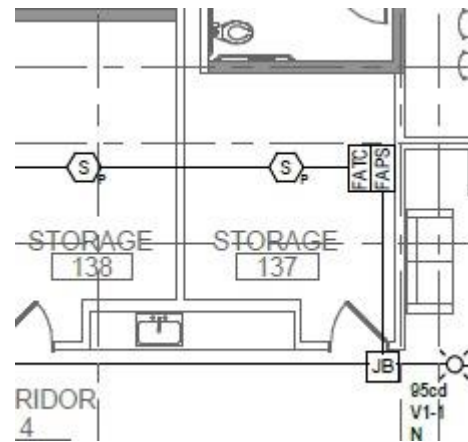
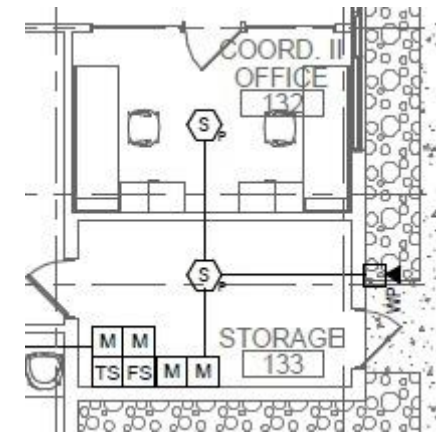
30- Check the 4 monitor modules in storage room, refer to (FA2.02)

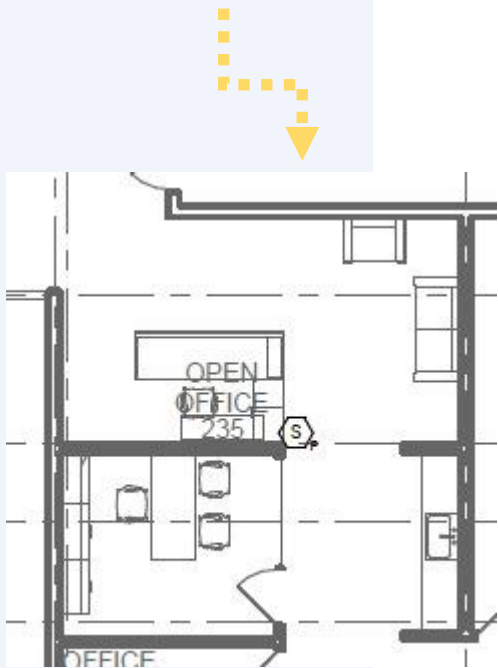
31- Check smoke detector location in offices as possible to avoid dark point.

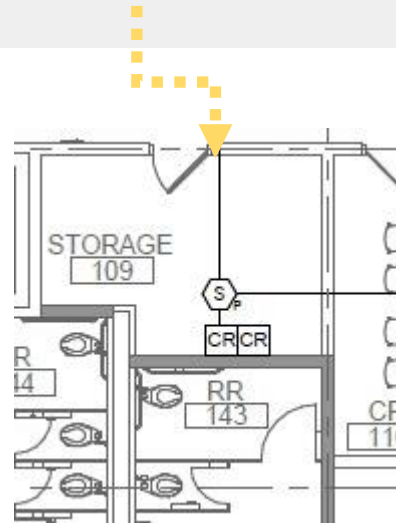
32- Check the two relay modules CR, refer to (FA2.01)

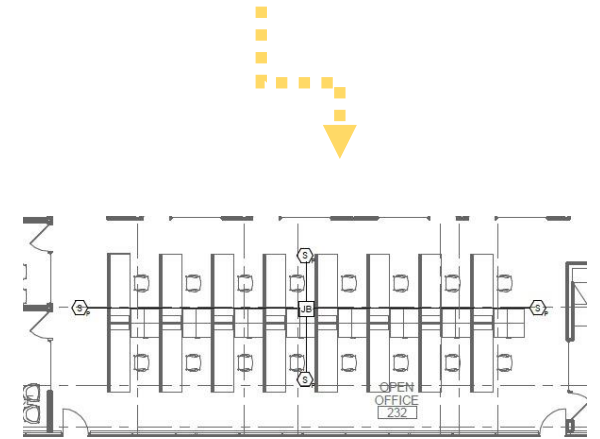
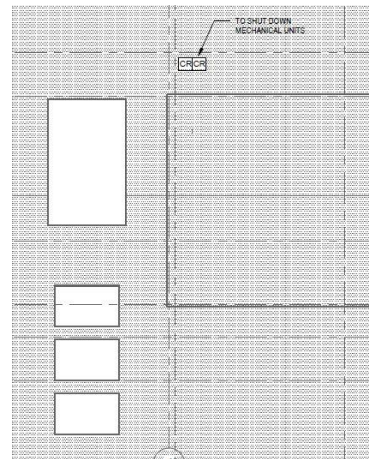
33- Check smoke detector locations/distribution in open office to avoid dark point (FA2.02)
