# OCEANSIDE UNIFIED SCHOOL DISTRICT DISTRICT SERVICES OFFICE

50% Construction Documents (issued on April 18, 2023)

Review Report –Rev 00 – June 19, 2023

(Documents analysis, coordination, integration and constructability)

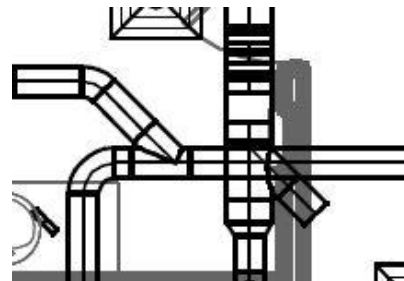
M2.01-M2.02

15-Check duct work fabrication specs to compile with SMACNA and other standards
